# AMD Alchemy™ Au1500™ Processor

## Document Revision History

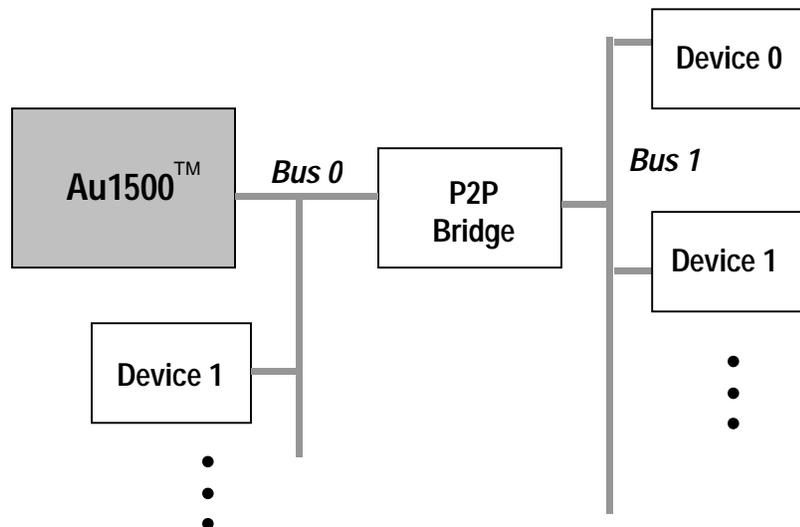
Most Au1500 processor users can achieve their goals without considering a P2P bridge. Those that do consider a bridge should be aware that any mastering device on the other side of a P2P bridge, where the target is the Au1500 processor, will eventually lead to a lock-up condition of the PCI bus or even the entire system.

The following diagram illustrates a multi-bus system where the Au1500 processor is the host, and devices exist on bus 0 and bus 1.

Configurations that are NOT Supported:

- Bus master devices on Bus 1 which target the Au1500 processor.
- P2P Bus Bridges cannot be used with the Au1500 processor in satellite mode. This may preclude the use of the Au1500 processor in some PCI board applications
