# AMD Geode™ SC1200/SC1201 Processor Silicon Revision D3.3 Specification Update

## Scope

This document discusses known issues of silicon revision D3.3 of the AMD Geode™ SC1200/SC1201 processor. The table below provides a summary of the issues. A detailed description of each issue, its impact and a recommended resolution/fix follow.

Silicon revision D3.3 is denoted as “33” in the part marking on the package (i.e., “(M) (C) 1999 33”).

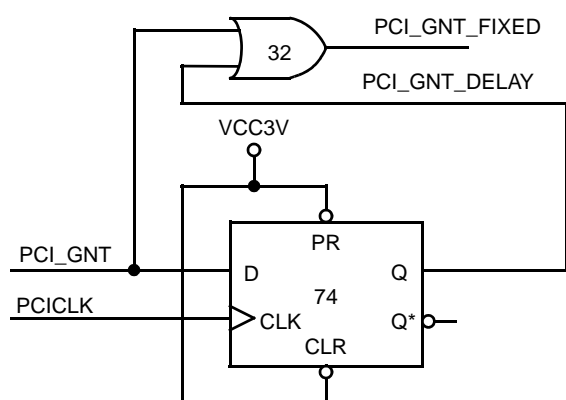
**GNT# Workaround**

1) Address stepping PCI bus masters assert the address one clock before asserting FRAME# and with the simultaneous GNTx# asserting and GNTy# deasserting, a drive fight condition will exist on the address and command signals. If this condition continues long enough, it could cause an incorrect address or command to be signaled and unexpected system behavior would result. This applies only to addressing stepping PCI masters connected to GNT1#.

Implication 2) For the very small number of devices that have this issue: connect the device to GNT0# or apply the external hardware shown below on the GNT1#. This will prevent the issue.
