# AMD Geode™ SC3200 Processor Silicon Revision D3.3 Specification Update

This document discusses known issues of silicon revision D3.3 of the AMD Geode™ SC3200 processor. The table below provides a summary of the issues. A detailed description of each issue, its impact and a recommended resolution/fix follow.

Silicon revision D3.3 is denoted as “33” in the part marking on the package (i.e., “(M) (C) 1999 33”).

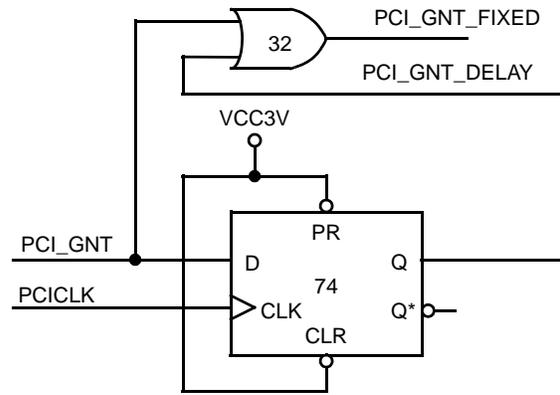
**GNT# Workaround**

1) Address stepping PCI bus masters assert the address one clock before asserting FRAME# and with the simultaneous GNTx# asserting and GNTy# de-asserting, a drive fight condition will exist on the address and command signals. If this condition continues long enough, it could cause an incorrect address or command to be signaled and unexpected system behavior would result. This applies only to addressing stepping PCI masters connected to GNT1#.

Implication 1) Connect address stepping PCI master to GNT1# or if the PCI device has configurable address stepping, configure the device so that address stepping is not performed.

Implication 2) For the very small number of devices that have this issue: connect the device to GNT0# or apply the external hardware shown below on the GNT1#. This will prevent the issue.
