## Validation of PhotoStress<sup>®</sup> Method for Stress Analysis on a Pipe Spool

**Industry/Application Area:** Oil & Gas Industry – Experimental Stress Analysis (Piping)

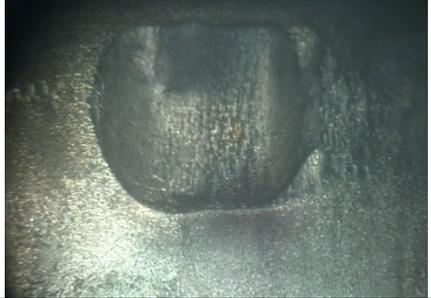
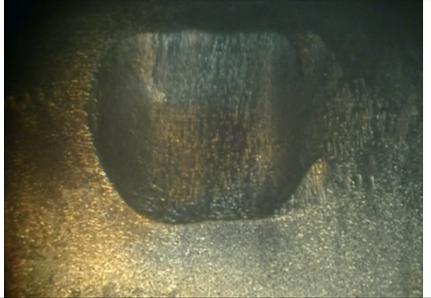
#### Location 1 / C1. Photoelastic Coating

Initial condition at no load condition.	Pale yellow fringe is observed but cannot clearly locate the high stress concentration area.	Blue fringe emerges at the notch in the defect – shows the highest stress concentration area when there is a significant load effect.

Based on our results, there was no significant difference in fringe color, i.e., the fringe color was pale yellow only, when the pressure was increased up to 15 bar. Thus, the compensator value was increased first to observe the area of high concentration. Blue fringe color was noted at the location that had the highest stress concentration. The fringe pattern emerged uniformly on the pipe nominal surface area (non-defect area) at Location c2. However, the fringe pattern emerged as a scattered pattern at the defect areas at Locations c1 and c3. This phenomenon indicates that there was a stress gradient at these locations and localized regions that were overstressed.

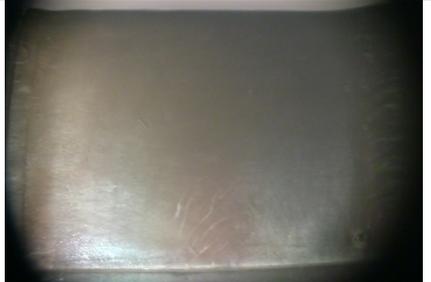
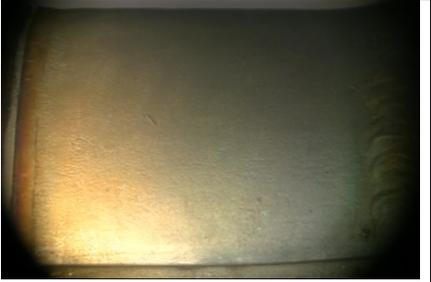
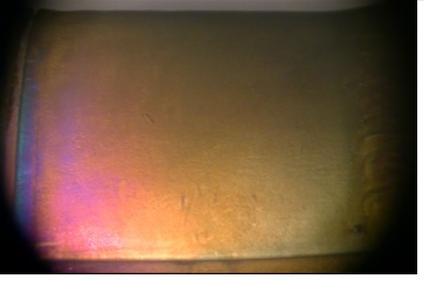
#### Location 2 / C2. Photoelastic Coating —A Nominal Thickness

Initial condition (at zero loading).	Pale yellow fringe emerges uniformly as pressure increases.	The fringe pattern changes from the left side and uniformly moves to the right side of pipe.

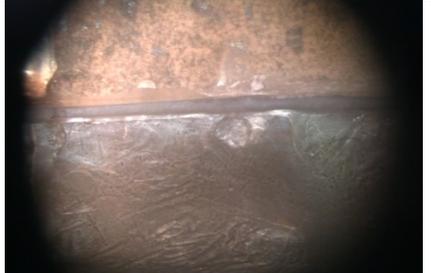
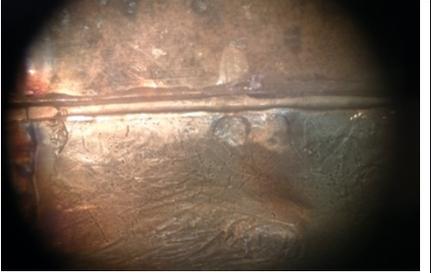
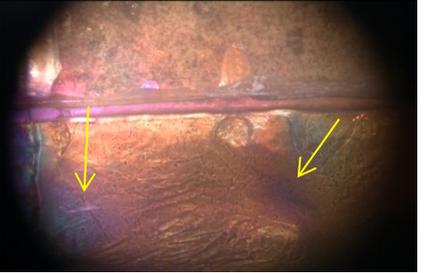
#### Location 3 / C3. Photoelastic Coating– Defect in the Composite Wrapping

Initial condition (unloaded condition).	Pale yellow fringe pattern appears as compensator values increases.	Blue fringe emerges at the dented area and left side.
