**VISHAY
PRECISION
GROUP**

PhotoStress®

Introduction to PhotoStress

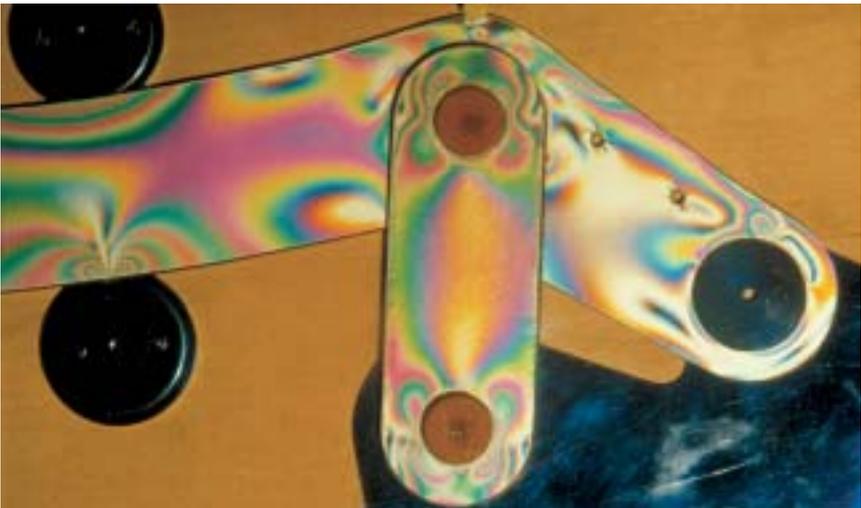
Fig. 1—PhotoStress pattern revealed on a mechanical controlled linkage system in a passenger jet aircraft.

displays the strains (or stresses) in a colorful, informative pattern (Fig. 1), which immediately reveals the overall stress distribution and pinpoints highly stressed areas. With an optical transducer (digital compensator) attached to the polariscope, quantitative stress analysis can be quickly and easily performed. Permanent records of the overall stress distribution can be made by photography or by video recording.

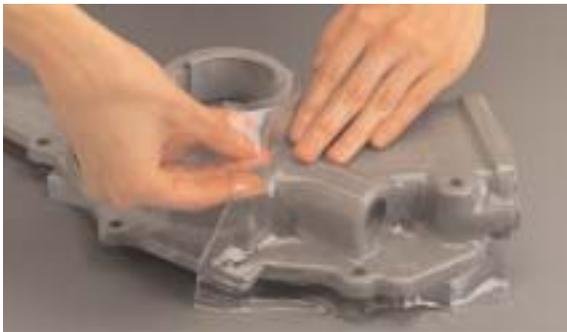
PhotoStress coating being contoured to the surface of a vehicle water pump casting.

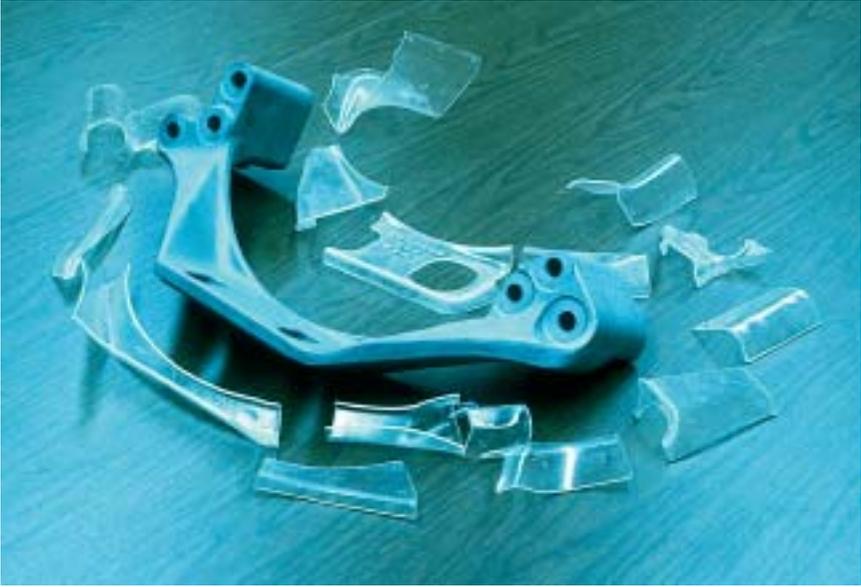
PhotoStress contoured shells ready for bonding to engine mount bracket casting.

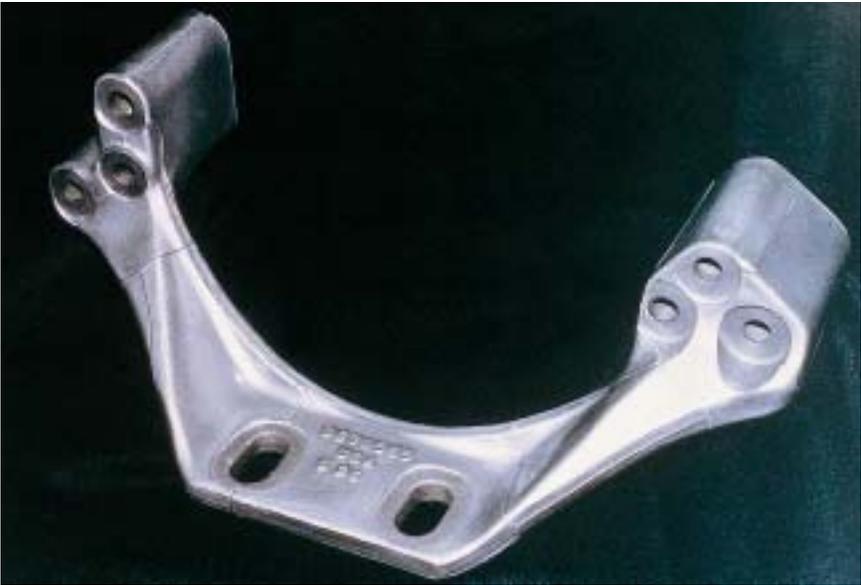
Engine mount bracket with PhotoStress coating bonded in place. Coating covers entire surface except in the immediate area of the bolt holes, and other areas where fasteners and completion hardware would physically come in contact with the coating.

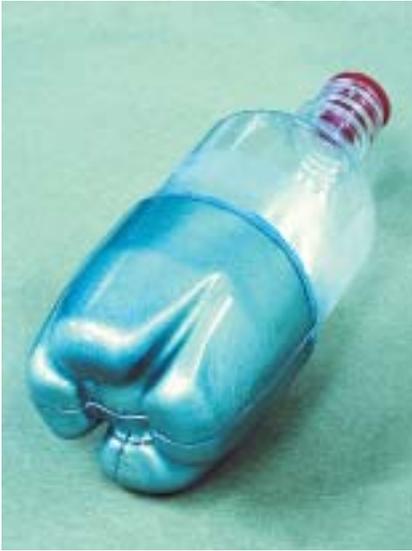
A plastic beverage bottle coated for comparison of PhotoStress and finite-element analysis.

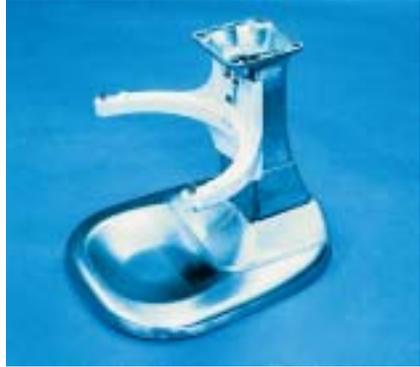
An industrial food processing mixer coated around the vertical support and base.

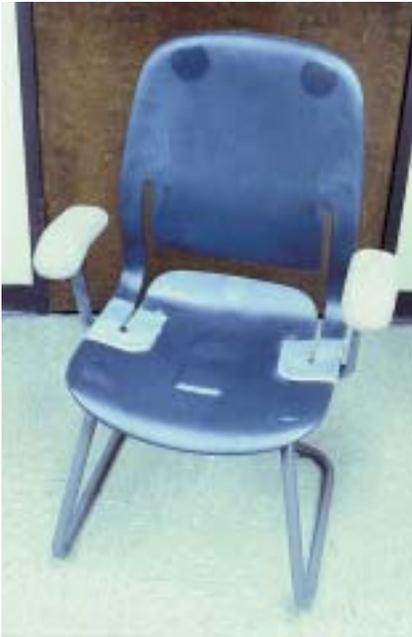
Chair showing coating applied to areas of seat which was designed for greater flexibility.

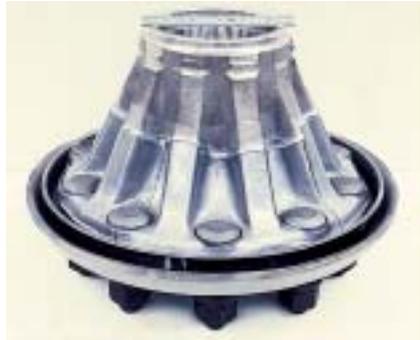
PhotoStress coating applied to rapid transit vehicle wheel hub.

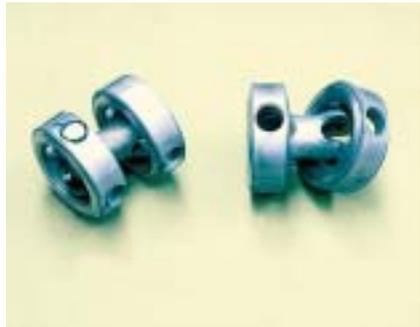
Newly designed universal joint coupling coated and ready for PhotoStress testing.

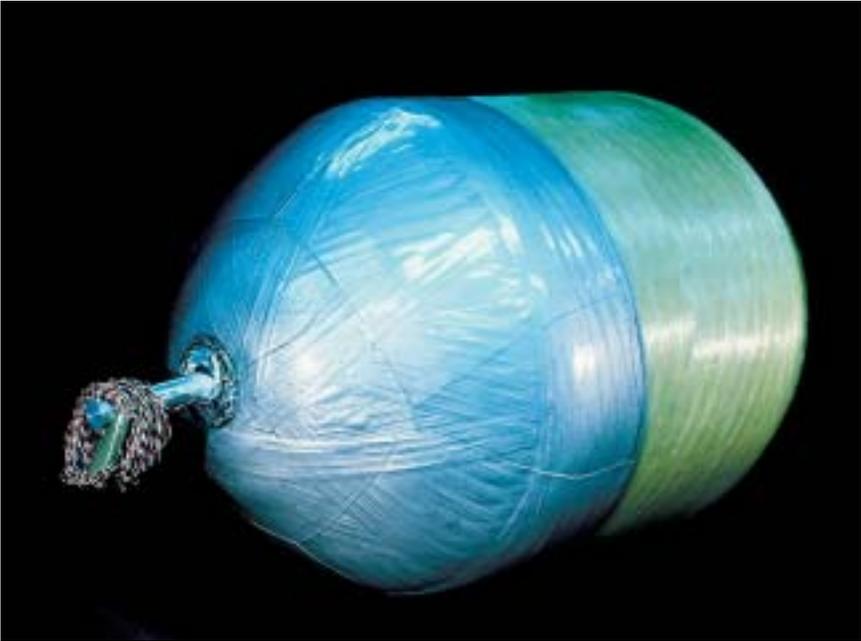
Filament-wound pressure vessel partially coated for testing. PhotoStress coating can be applied to any material regardless of its homogeneity.

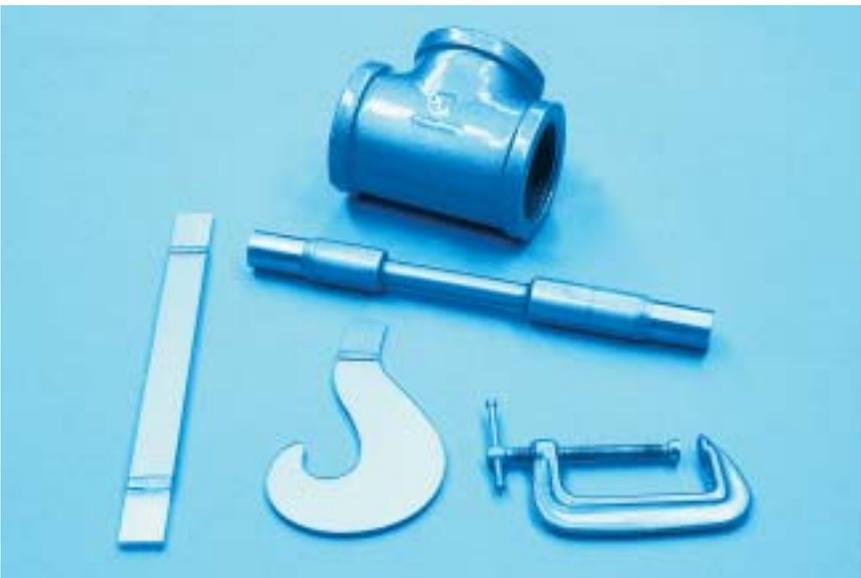
Typical samples that have been coated for conducting student experiments in PhotoStress testing at colleges and universities.

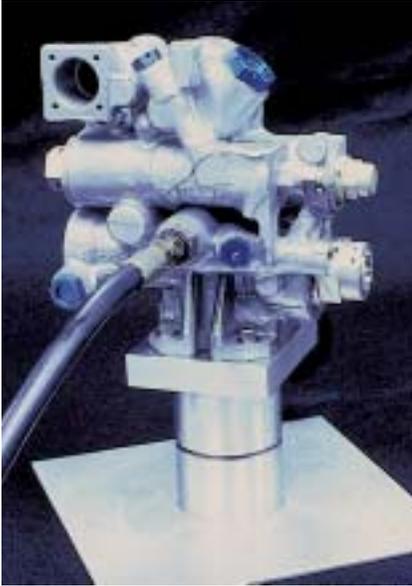
PhotoStress coating applied to a complex shaped augmentor fuel casting from a jet engine.

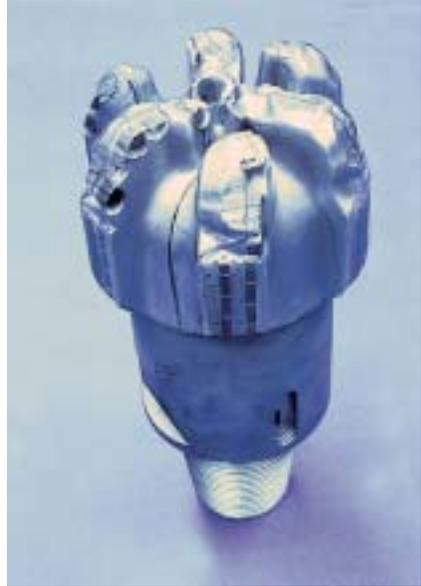
PhotoStress coating applied to an exploratory oil field drill head.

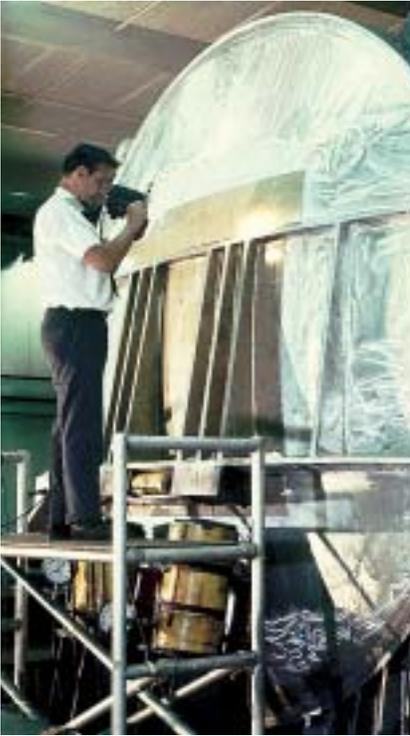
A large pressure container with PhotoStress coating applied to a “ribbed” reinforced area.

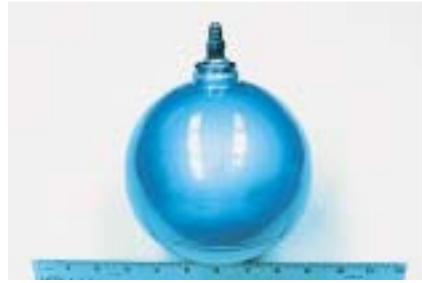
Spherical pressure container with PhotoStress coating applied to entire surface area.

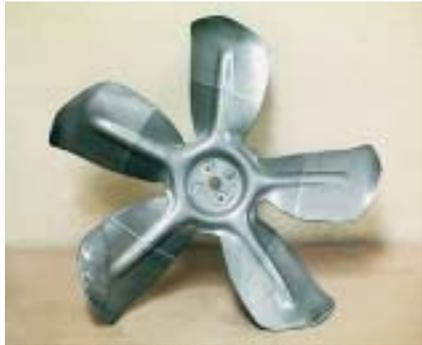
PhotoStress coating applied over the entire surface of a fan which was dynamically tested.

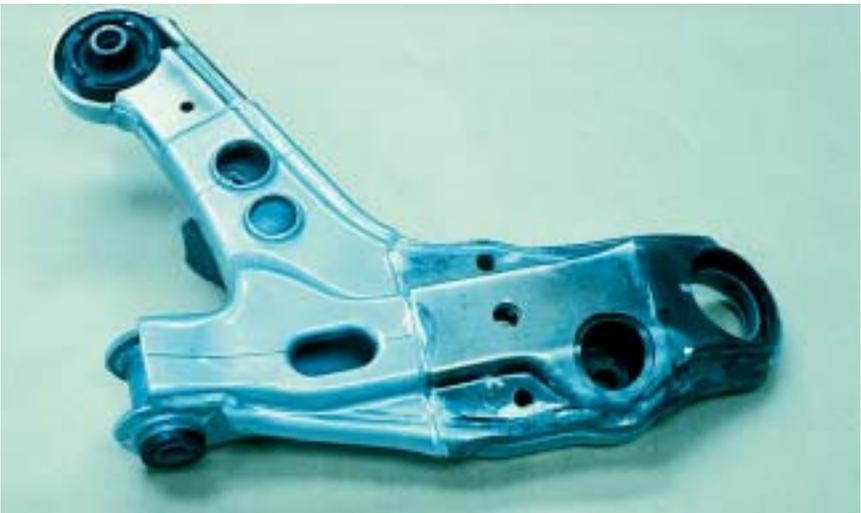
An automotive control arm bracket partially coated for PhotoStress analysis.

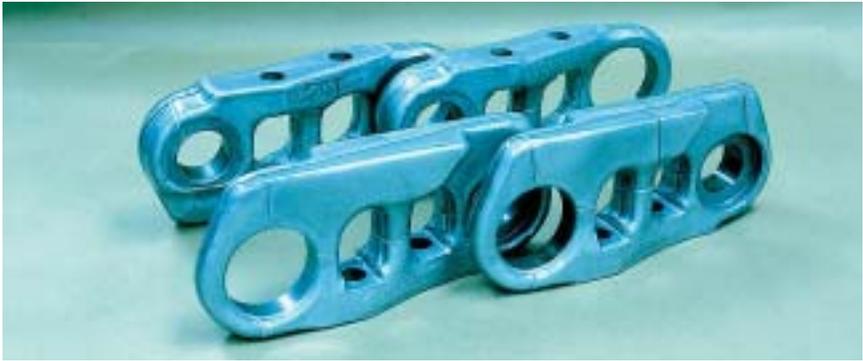
PhotoStress coating applied to track links from an earth-moving vehicle.

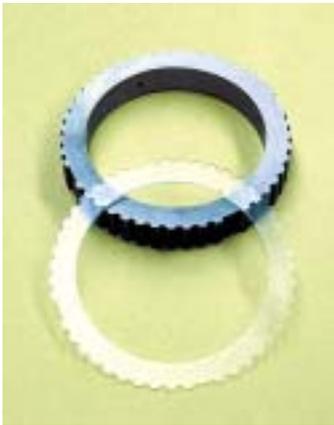
Coating ready for bonding to geared ring.

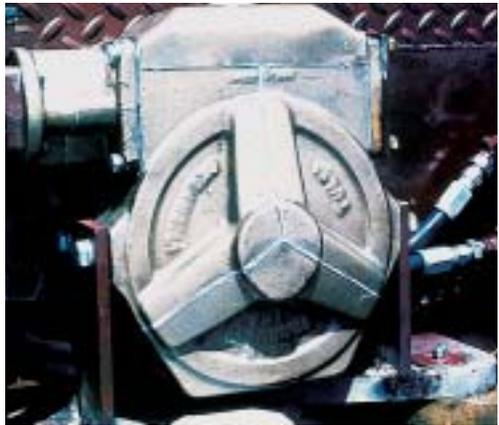
PhotoStress coating applied to the cast housing of a hydraulic drive system of a fire engine.

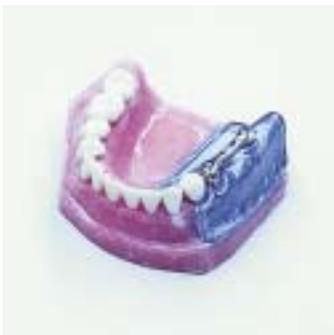
PhotoStress coating applied to a dental model used for design of bridge components.

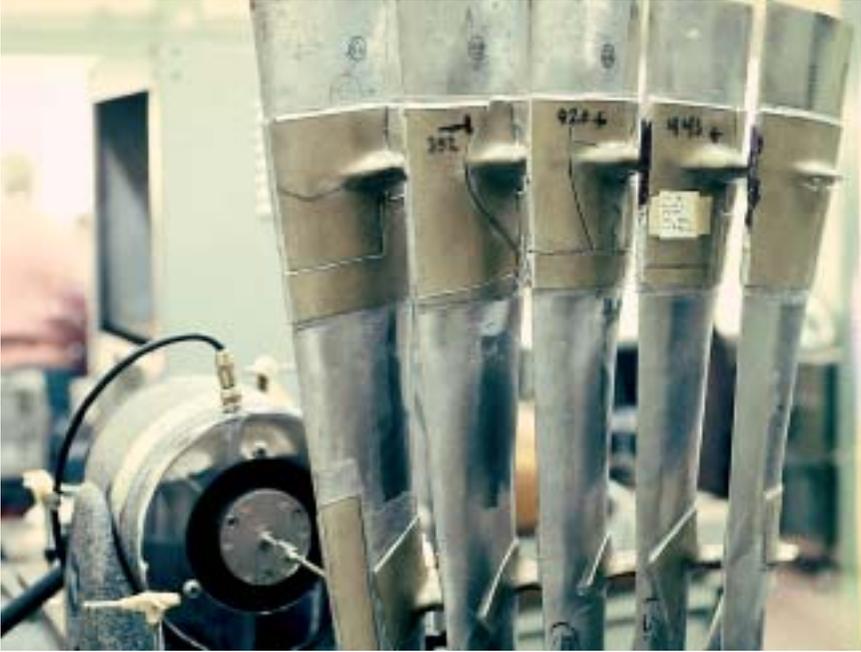
A section of steam turbine blades coated for PhotoStress analysis under dynamic test conditions.

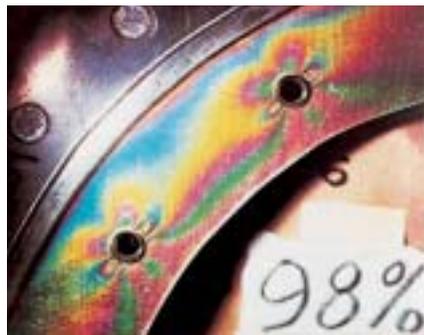
Fig. 1

Airplane Window Frame. Several tests have been performed on the window frame of a jet passenger transport. Figure 1 shows the color fringe pattern in the window frame when it was subjected to 98 percent of the maximum load. Note the stress concentration around the holes.

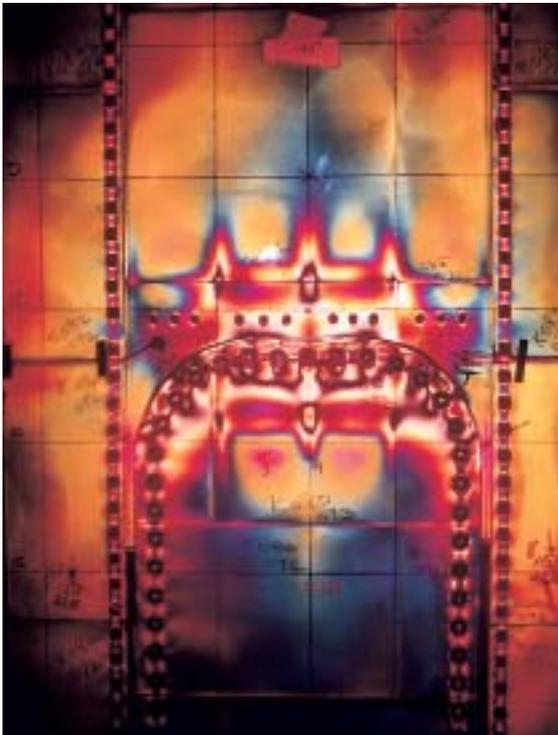
Fig. 2

Figure 2 shows the PhotoStress pattern on a section of wing under 90,000 lb (20 KN) load. Note that the fuel access door, designed as a nonload-carrying member, exhibits higher stresses than the adjacent area of the wing. Figure 3 reveals the existence of permanent deformation in the reinforcing ribs of the fuel access door following removal of the load. In this view (the reverse side of the door) the residual fringes under no-load conditions testify to elastoplastic buckling of the ribs.

Wings and Access Doors. The wings and fuel access doors of the Lockheed C-141 military jet transport have been analyzed under compression loads. The analysis of the stress distributions included both the elastic and elastoplastic ranges of deformation. In addition, one requirement was to establish the load that initiated elastic buckling. Buckling was observed during the loading of the wing while photographically recording the photoelastic pattern. The onset of buckling was evident by the sudden appearance of asymmetric high fringe orders on one section of the wing. The initiation of the buckling was detected photoelastically before any nonlinearities were observed in the displacement gages or the load record from the testing machine.

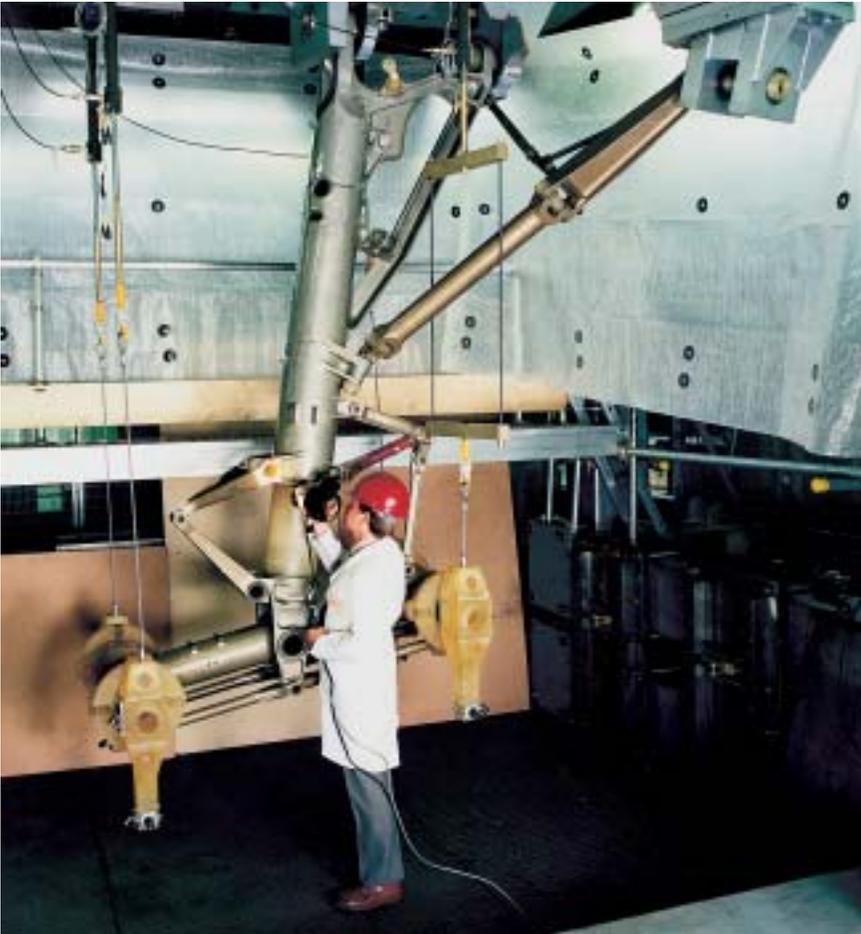
Fig. 4

Figure 4 shows PhotoStress testing in progress on the main landing gear of the Airbus A330/A340 passenger aircraft. In this case, the

landing gear itself is a scale model made of an epoxy resin material for early design testing. After a thorough survey and analysis of the surface strain distribution on all structural components is completed, suggested changes are incorporated into the initial metal prototype. Additional Photostress analysis is then performed to help establish final design criteria prior to manufacture and acceptance testing of the actual landing gear.

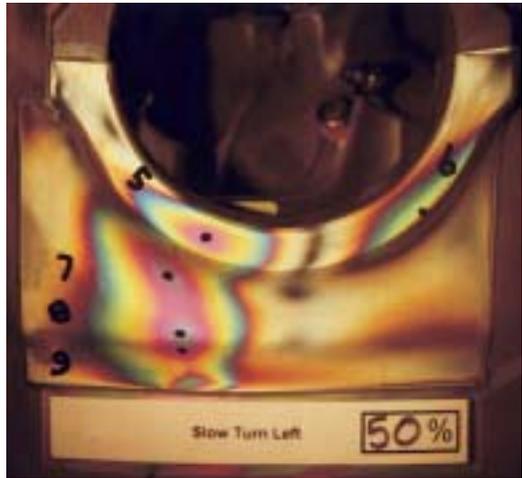
Fig. 5

Figure 5 shows a PhotoStress fringe pattern at a specific area of an Airbus gear during a static test sequence. Figure 6 below shows final prototype testing on a landing gear from a military jet fighter aircraft. In this case, the entire surface of the gear was coated for analysis. Figure 7 shows the PhotoStress fringe pattern over several sections of the landing gear.

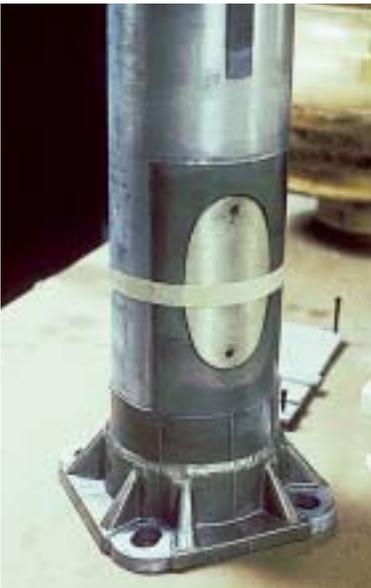
Fig. 18

Aluminum Support Post. PhotoStress testing determined the primary cause of structural failure at the base of an aluminum post used to support traffic lights, signs, etc. Figure 18 shows the coated post, and Figure 19 shows that yielding occurred in the welded area of the base after the bolts were tightened. Adding service loads to the pre-existing high-tensile stress condition caused the premature failure. PhotoStress analysis also suggested that the detrimental effects of assembly could be greatly reduced by modifying the cast base. This was accomplished by introducing a slight degree of concavity into the bottom surface of the base, which placed the initial assembly stresses in compression instead of tension. With this modification, future failures were eliminated.

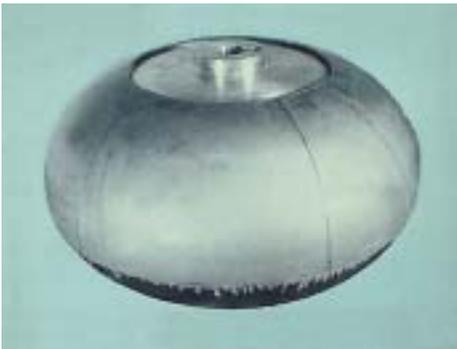
Fig. 27

symmetrical points tangent to the cut-out edge. After the gages were installed and the vessel pressurized, the strain measured was grossly inconsistent from one symmetrical point to the other. It was then decided to apply a PhotoStress coating to a test vessel (Fig. 27) to get a clear picture of the strain distribution around the cut-out to help explain the erratic strain gage results. The fringe pattern (Fig. 28) clearly shows the reason for the differing strain gage results around the edge of the cut-out. Instead of the assumed uniform strain distribution around the cut-out, a repeatable series of alternating fringes, with low strain areas in between, accounted for the erratic strain gage readings. Some gages were placed over the higher strain fringe areas, while others were placed between fringes. The reason for this unforeseen strain distribution lies within the geometry of the filament-winding process. At the conclusion of the winding, the final layer of glass

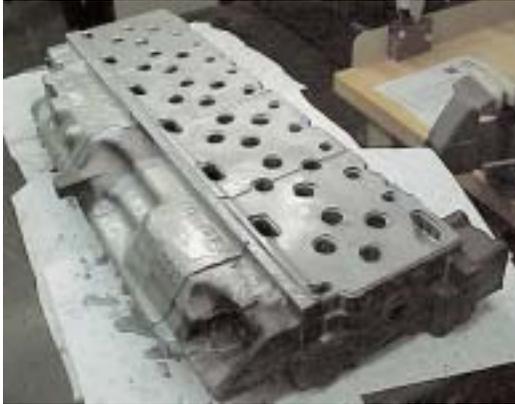
Fig. 38

One such example of the detection and measurement of residual stress after a process change in a cylinder head casting is illustrated in the above figures. Figure 38 shows the cylinder head after PhotoStress coating has been applied, and Fig. 39 shows the reflection polariscope set-up for the measurement process. Figure 40 shows the cylinder head after sectioning, and Figure 41 shows the residual stresses relieved at one particular section of the head.

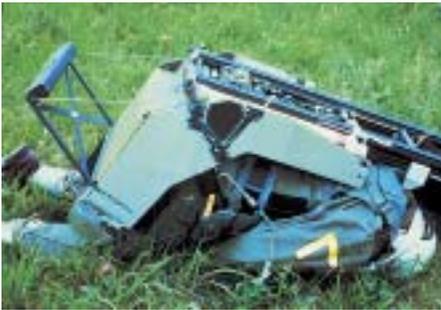
Fig. 42

Aircraft Ejection Seat. PhotoStress coatings were bonded to parts of a military aircraft ejection seat. The seat, containing a dummy pilot, was installed in a fuselage section for testing. Once ejected, the seat and dummy were returned to earth by parachute as shown in Fig. 42. The PhotoStress-coated sections of the seat were then observed with a reflection polariscope to detect yielding that occurred during the test event as shown in Fig. 43.

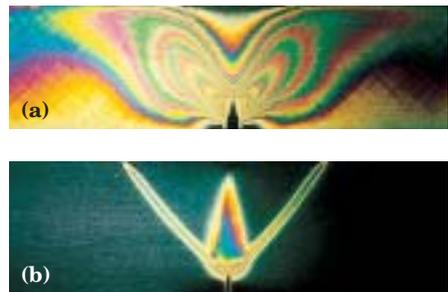
Fig. 44

Materials Testing. PhotoStress was used to study the post-yield strain behavior on “notched” tensile test specimens. Figure 44a shows a broad plastic strain field developing over most of the surface of one test sample, while Fig. 44b shows initial yielding occurring in the form of Lueder's lines (slip planes) in the other.

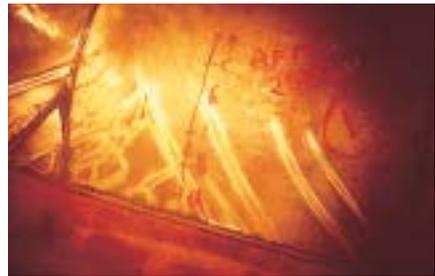
Fig. 46

Figure 46 shows such a permanent fringe pattern in the form of Lueder's lines, observed on the interior wall of a large, thick walled pressure vessel after proof testing.

1. Coat the inside of the vessel in the area of interest.
2. Pressurize the vessel to a predetermined level; after emptying it, examine the coating for any permanent fringe patterns.
3. If no pattern is observed in Step 2, repeat this procedure at higher pressure levels until permanent patterns are observed or the maximum allowable pressure is reached.

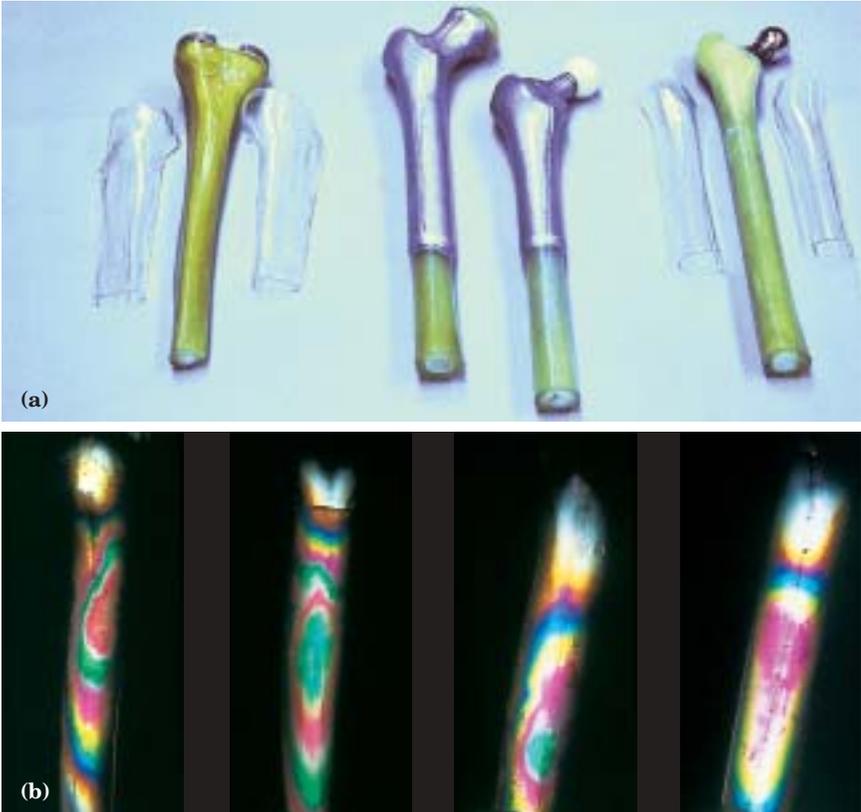
Fig. 48

Example 2. Figure 48a shows simulated femoral test specimens being prepared for PhotoStress analysis of various types of hip implants, and Fig. 48b shows the resulting stress distribution of the different implants used. After the modeling tests have been completed, selected prosthesis are then chosen for implant in real bone for further PhotoStress testing.

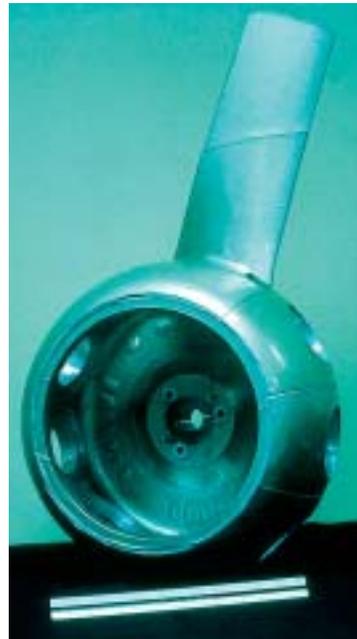
The coated fan is illustrated in Fig. 52 and the dynamic test setup is

Industrial Fan. A photoelastic coating was applied to the hub and blades of an axial-flow fan. The fan was dynamically balanced and then operated at normal rotational speed. Two tests were conducted to assess the merits of two different blade retainers. A reflection polariscope fitted with a stroboscopic light was used for the measurements, and synchronization of the stroboscope and fan was accomplished with a photoelectric cell. The discontinuous light intensity needed for the photocell signal was obtained from a piece of black tape on one area of the fan shaft. The following conditions were found:

1. Assembly stresses greatly exceeded dynamic stresses and produced plastic deformations in certain areas.
2. Centrifugal stresses were negligible.
3. Stress concentrations were almost totally absent in the blade fillet area, indicating excellent force transmission between the blade and hub during fan rotation.
4. One of the blade retainers created assembly stresses three times higher than the others.

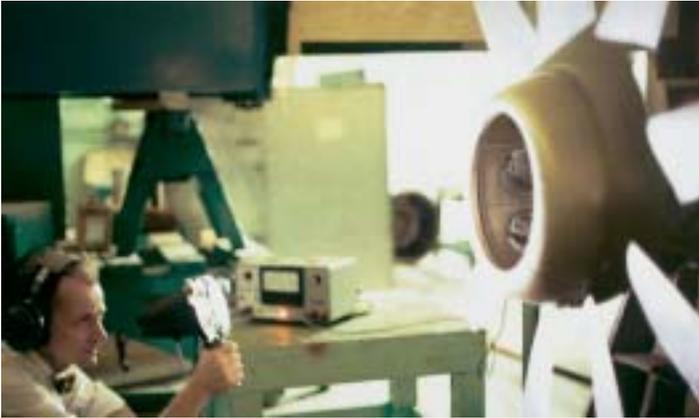
Fig. 53

shown in Fig. 53. Figure 54 shows the static strain pattern produced by assembling the hub to the shaft, and Fig. 55 shows the assembly strain pattern in the fillet of one blade.

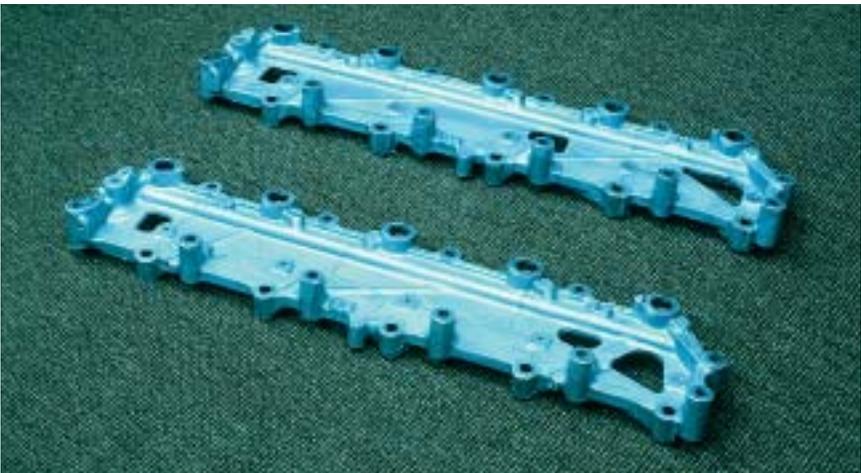
Fig. 57

Figure 57 shows two typical housings with the PhotoStress coatings bonded in place. Each test housing is bolted to its own unique fixture which simulates the actual mounting pads common to the diesel engine. This housing/fixture assembly is used in conjunction with a conventional hydraulic testing machine to apply:

The test sequence begins by first bolting the housing to the test fixture, and then observing the PhotoStress coating with a reflection polariscope to locate and measure points of initial assembly stress. Following static analysis of the assembly stresses, a stroboscopic light is installed on the reflection polariscope for observation and measurement of the stresses when the dynamic loads are applied. Figure 58 shows a typical test setup. The insert shows the PhotoStress fringe order on a typical Jake Brake housing resulting from bolting (assembly) only. These are the mean or static stresses. The combined fringe orders pattern when the superimposed internal hydraulic pressure load is applied is then obtained. The difference between these two loading conditions establishes the cyclical, or alternating, stress level.

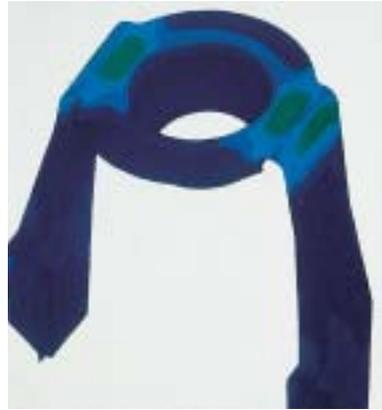
Fig. 60

Coil Spring Support Bracket. A more complex problem where PhotoStress was used to assist in the refinement of a finite-element model was in the design of an automotive coil spring support bracket. The stress distribution on the bracket as defined by FEA is shown in Fig. 60. It can be seen that the overall stress levels are low, with the absence of bright colors, and no significant stress concentrations are present. After manufacturing the initial prototype of the actual bracket, it was PhotoStress tested to verify the accuracy of the computer solution. The PhotoStress results showed a more complicated stress distribution than the finite-element model and revealed stress concentrations at specific locations on the bracket (Fig. 61). After witnessing how the spring loads were distributed to the bracket during the actual test (Fig. 62), it became clear that these load

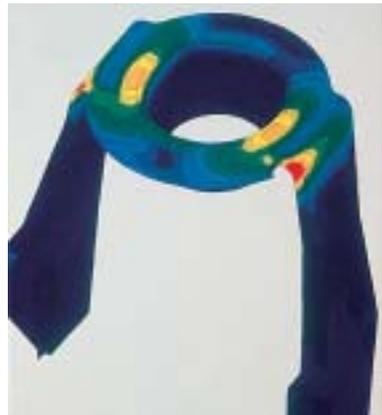
Fig. 63

inputs (spring expansion, compression, and variable bending) were not properly defined for the finite-element model. As a result of the PhotoStress analysis, the finite-element model was modified to more closely match the PhotoStress test results as shown in Fig. 63. Ongoing design changes were then incorporated into the bracket and more realistic finite element results were obtained with a better understanding of the load input distribution provided by PhotoStress testing.
