Specification Update

AMD Alchemy™ Au1000™ Processor

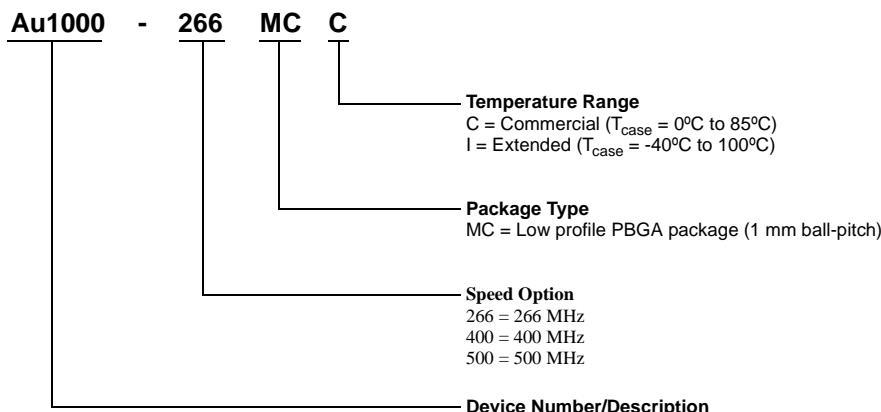
4. Ordering Information, page 336

Valid Combinations

Au1000-266	MC	C
Au1000-400		
Au1000-500
