Model 2450 System SourceMeter®

Version v1.1.0s Firmware Release Notes

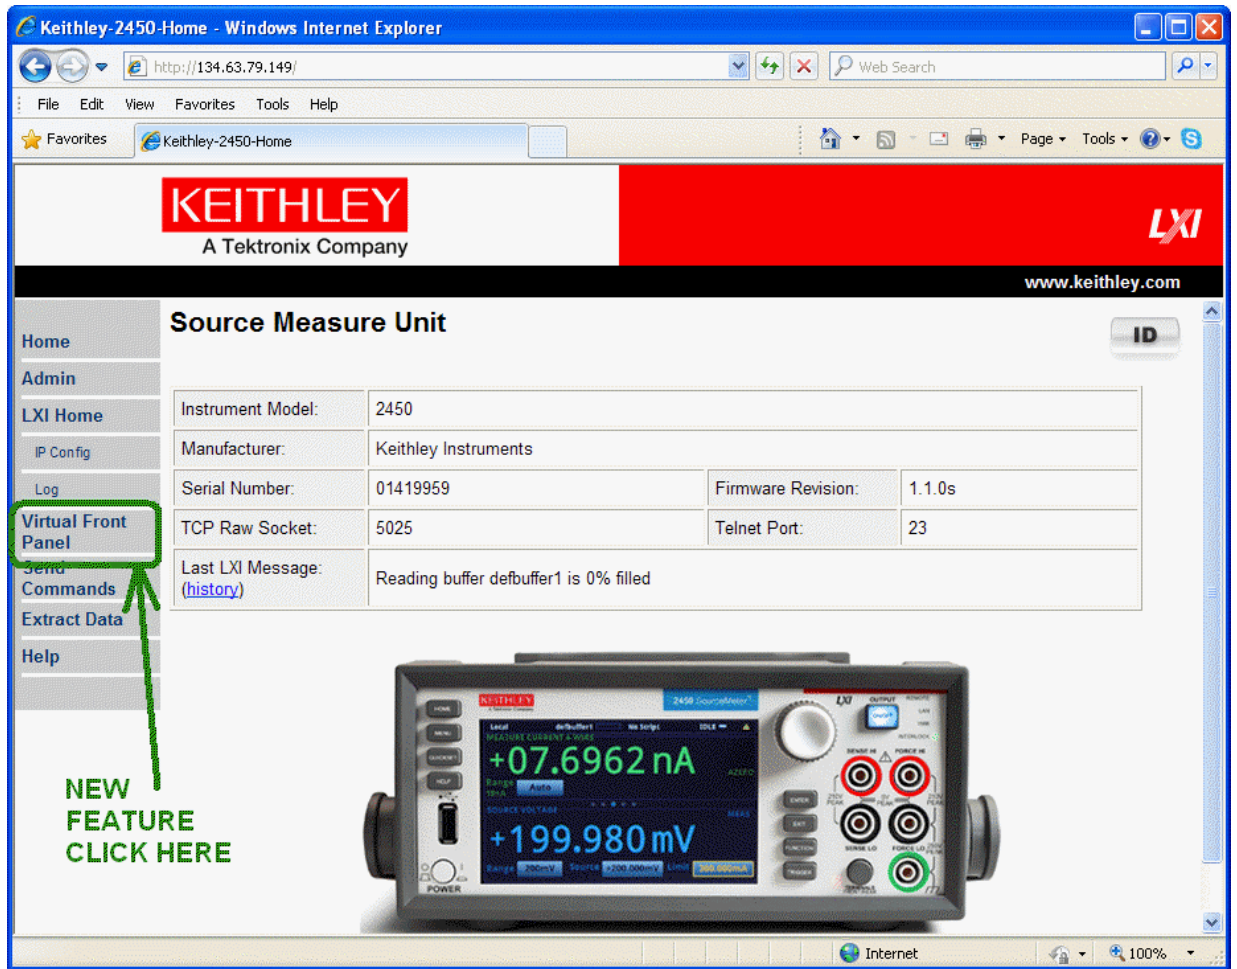
To access the new Virtual Front Panel, access the 2450 through Ethernet using your favorite Internet browser.

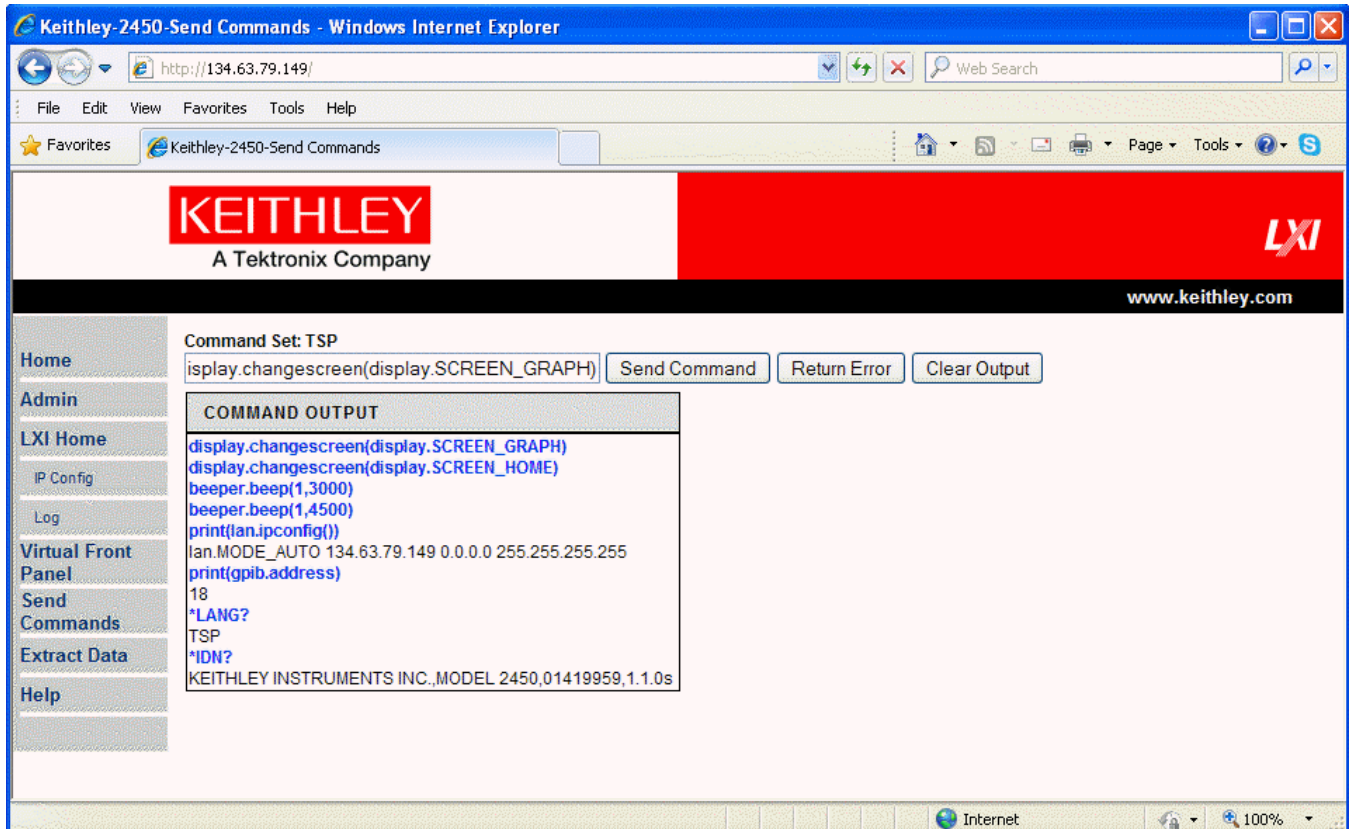
The 2450 built-in webpage has been enhanced to show a historical list of commands recently sent to the instrument. This new COMMAND OUTPUT window has been added to the Send Commands section of the webpage.
