# Model 2450 System SourceMeter®

## Version v1.3.0s Firmware Release Notes

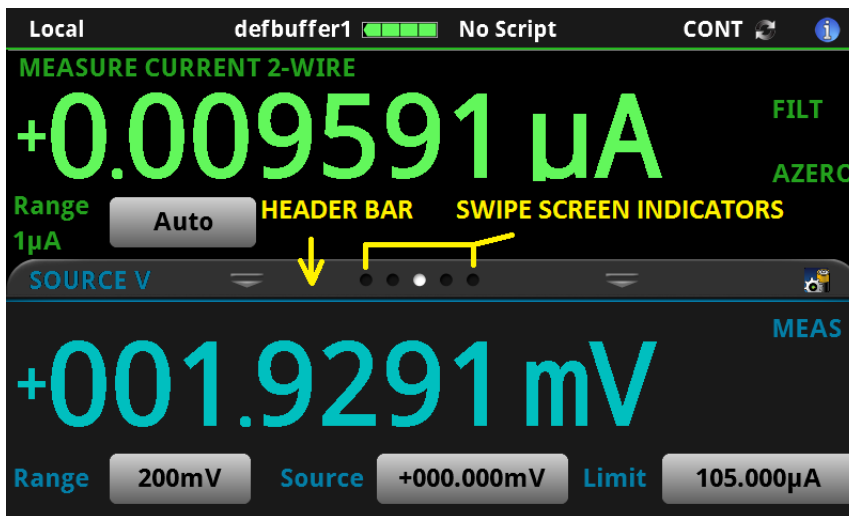
- e. Swipe Down on the Home screen will display larger readings.
4. Tabs and Buttons: Throughout the user interface multiple data display options have been made available through tabs (header bars) with swipe screen indicators to show how many options are available and which display tab is active.

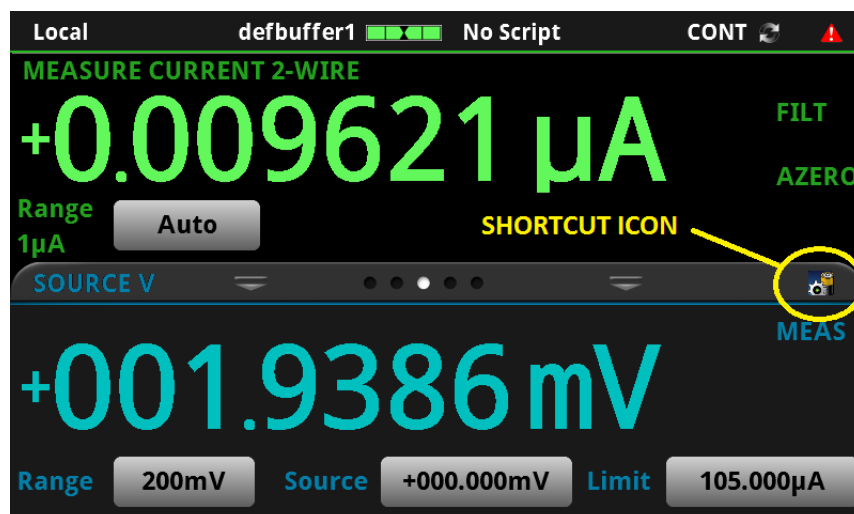
Add a direct shortcut from the HOME view measurement line to the measurement settings menu.

A shortcut icon has been added to the swipe bar on the HOME source/measurement tab.
